ADA Self-Evaluation & Transition Plan

2007 Survey Update

TOWN OF
WINDSOR

Prepared by Castle Code Consulting, December 2007

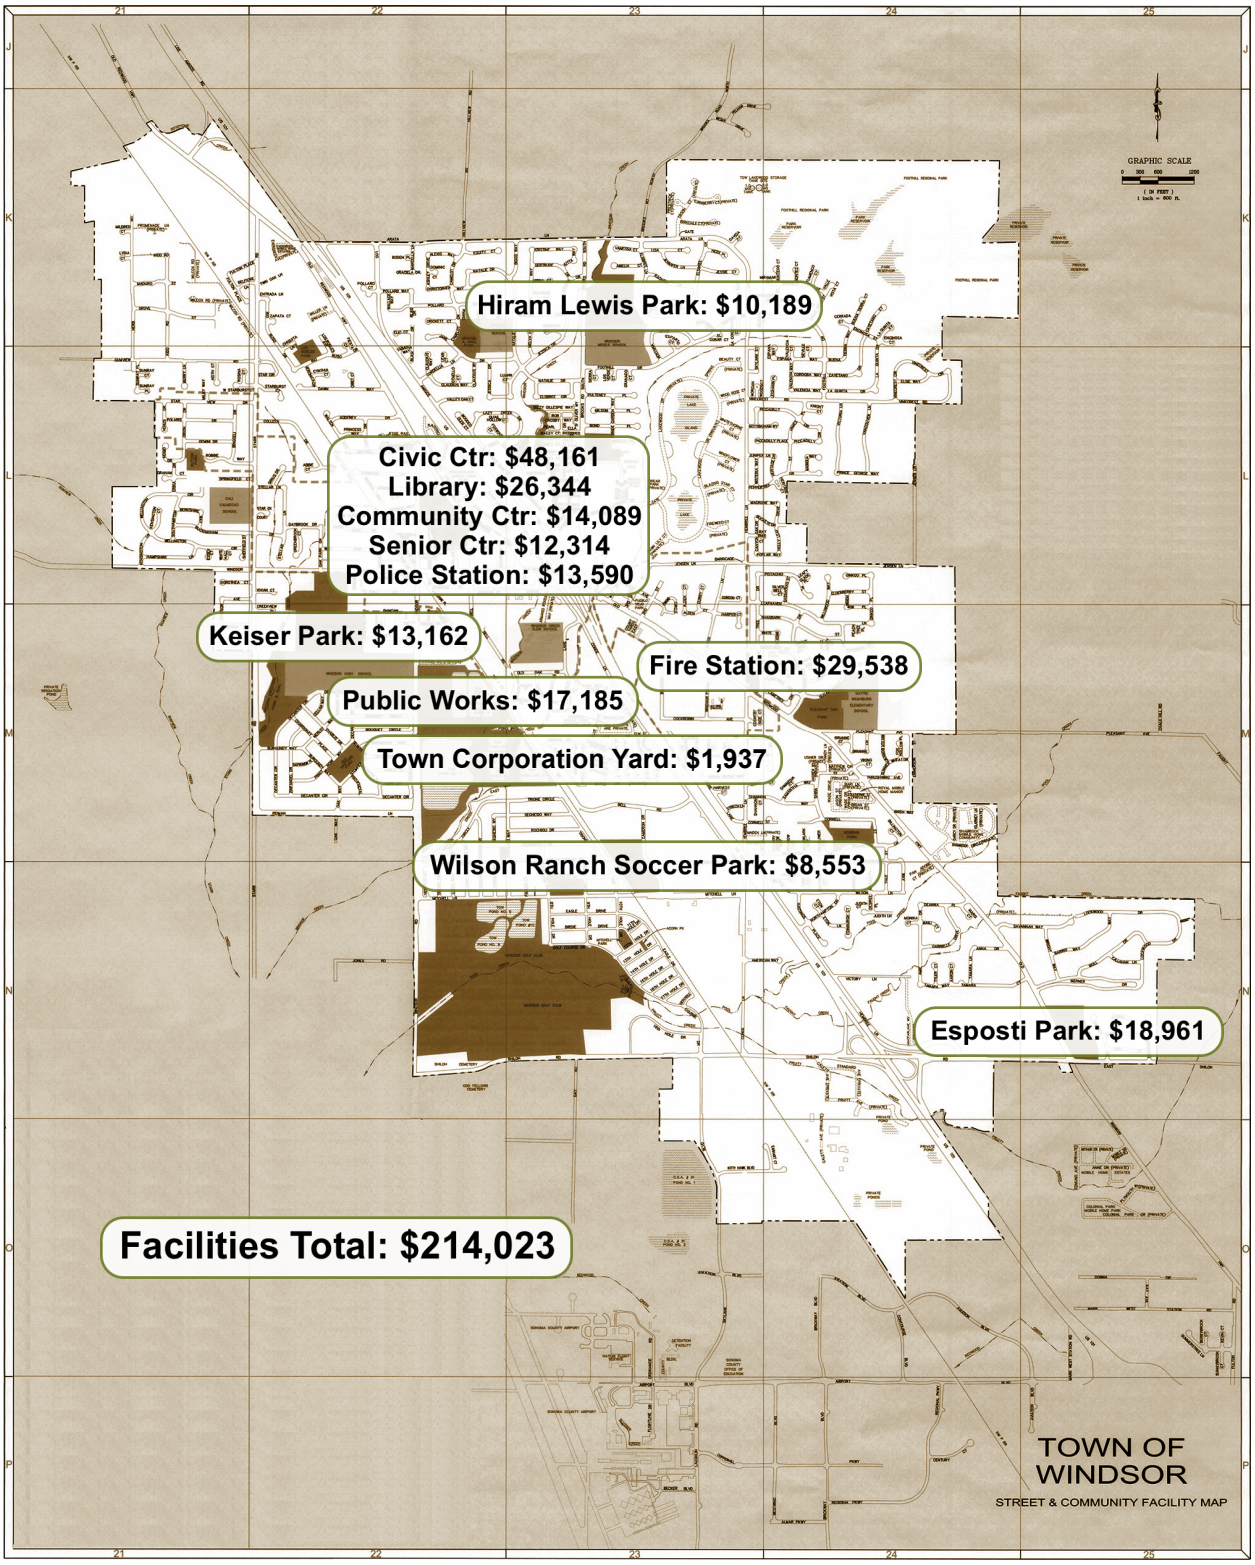
Esposti Park
1.13.3 Parking Lot

Element	Comply		Evaluation / Proposed Action	State Code	Federal Code	Cost
	Yes	No				
Site Entrance Signage	*					
Site Accessible Route of Travel	*					
Required Accessible Stalls	*					
Parking		*				
Ramps		*	Ramp extends into the loading zone. Remedy by relocating ramp into sidewalk.	1129B. 4.3	4.7.8	$2,568.00
Parking Stall/ Aisle Slope (2% max)	*					
Parking Space Signage	*					
Parking Space Design	*					
Parking Space Striping	*					
						$2,568.00

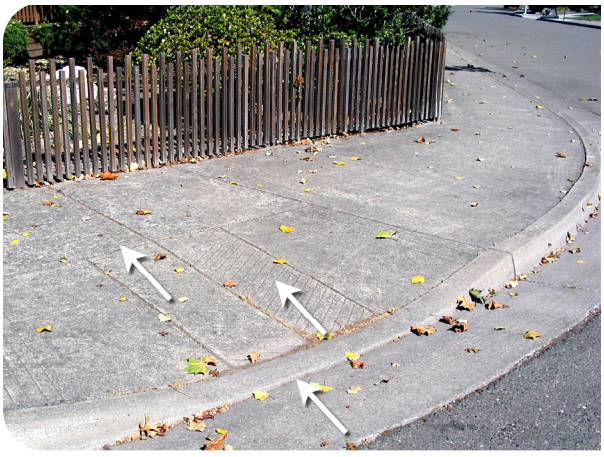
Improper grooves, cream center, lip on ramp

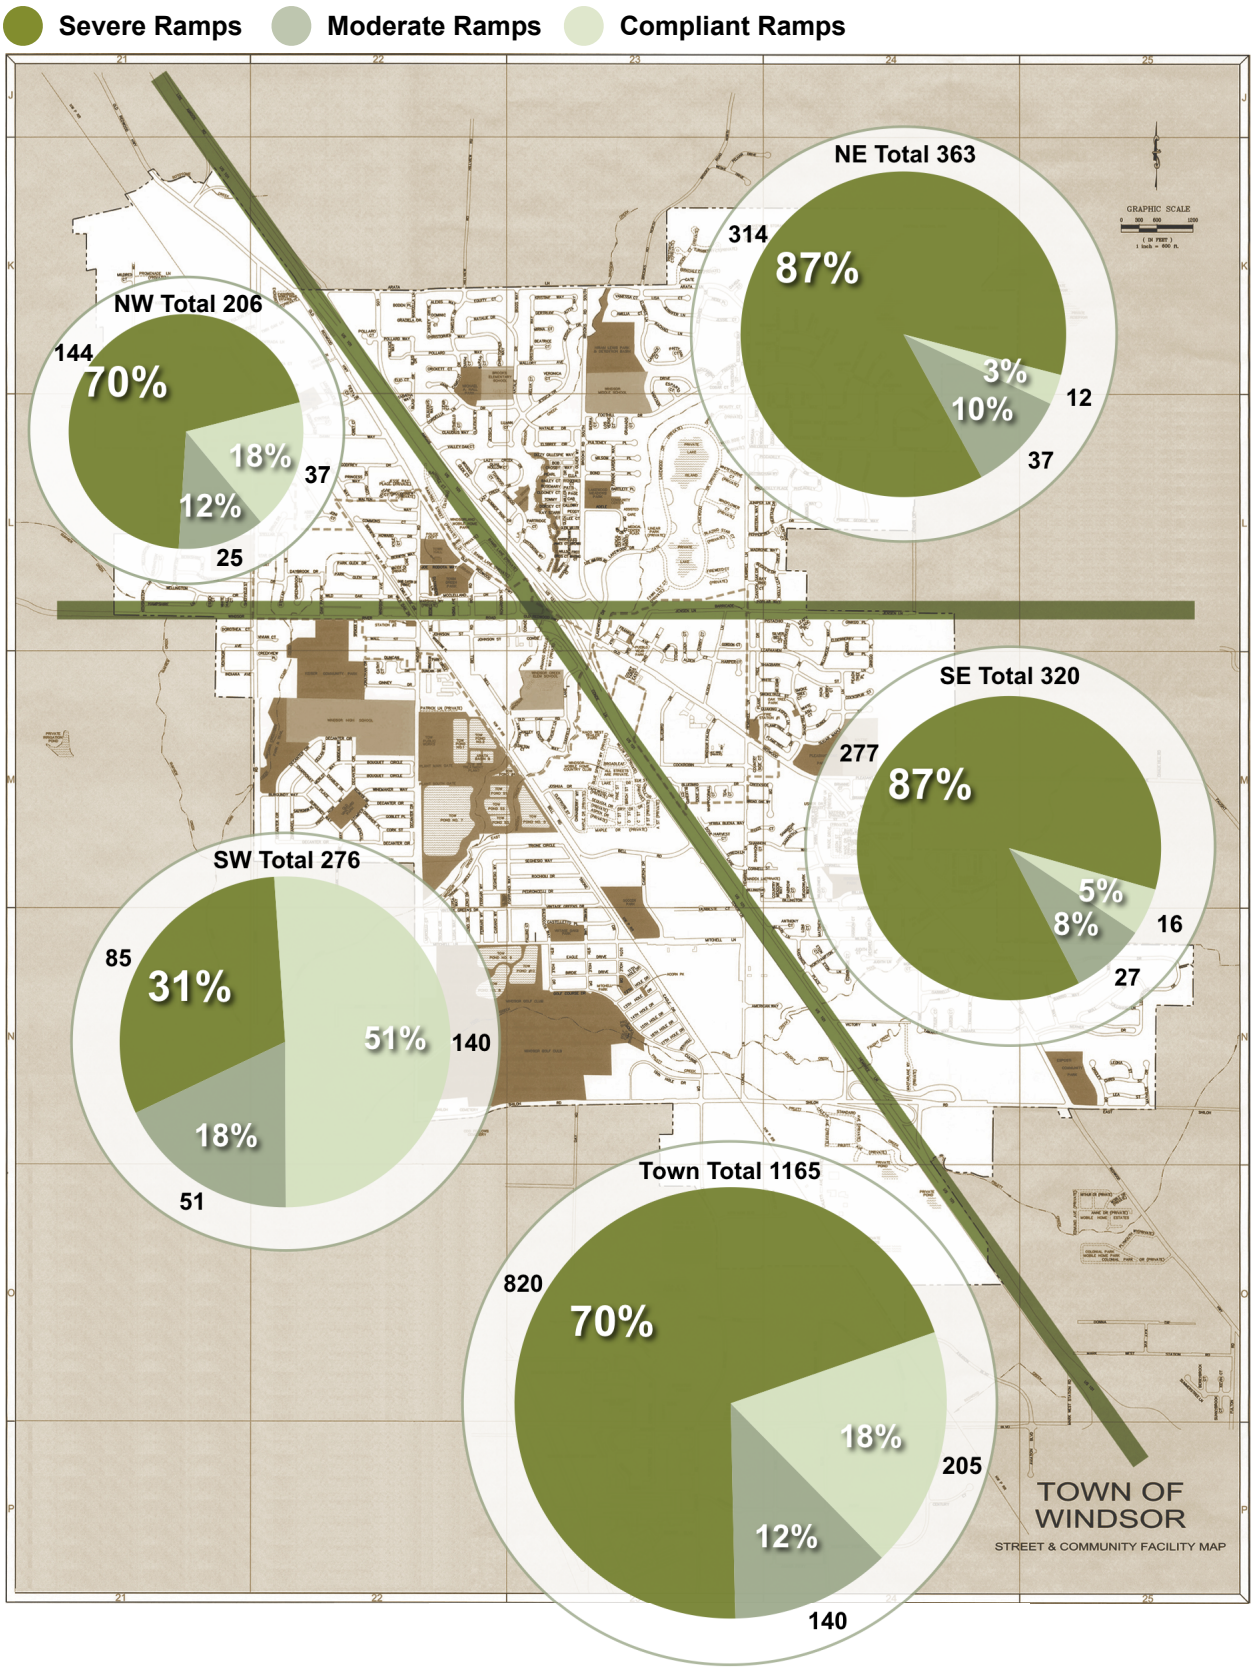
Intersection	48" min width	Slope exceeds 8.33%	Flared side slope less than 10%	Level Landings	Smooth trans-itions	12" Groove border	Trun-cated domes	Cross slope less than 2%	Com-ply	Estimated Cost	Comments
Windsor River Rd- Windsor Rd (SW)				2.9		N				$1,143.00	
Winter Born Way- Pleasant Ave (SE)		9.2		4.3		N		3		$1,143.00	Cream
Winter Born Way- Pleasant Ave (SW)		8.9		3.3		N		2.9		$1,143.00	Cream
Winter Born Way- Summer Wheat Dr (NE)				3.3	N	N				$1,143.00	Cream
Winter Born Way- Summer Wheat Dr (NW)				2.4	N	N		4		$1,143.00	Cream
Wisteria Way- Juniper Ln (SE)			16.1	3.9			6.2	2.9		$1,143.00	
Wisteria Way- Juniper Ln (SW)				2.9			6.5			$1,143.00	
Wisteria Way- Peppertree Dr (NE)							6			$967.00	
Wisteria Way- Peppertree Dr (NW)				2.6						$468.00	
Wooded Glen Ct- Lazy Creek Dr (NW)				2.5			6.1			$1,143.00	Cream
Wooded Glen Ct- Lazy Creek Dr (SW)										$523.00	Cream
Wright Way- Savannah Way (SE)				3				3.8		$1,143.00

Wright Way- Savannah Way (SW)				2.5						$468.00	
Yale St- Wilson Ln (NE)				4.1	N	N				$1,143.00	Cream
Yale St- Wilson Ln (NW)				3.1	N	N	6.5			$1,143.00	Cream

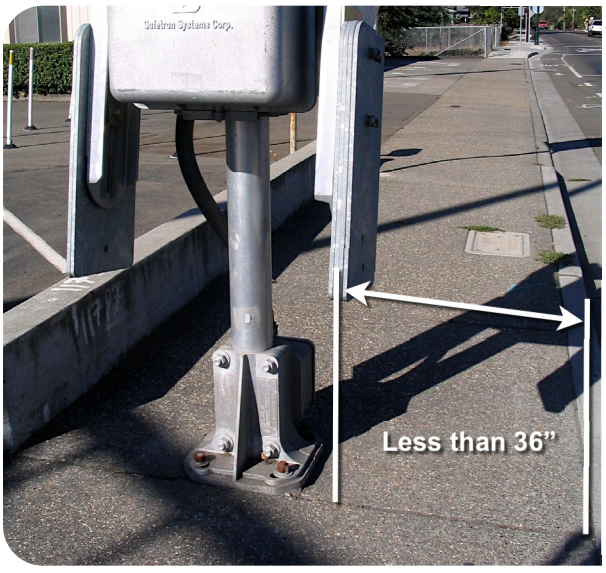
Sidewalk obstructed, less than 36 inches
