PHASE I ENVIRONMENTAL SITE ASSESSMENT REPORT

790 Shiloh Road

Windsor, California 95492

Report Date: December 10, 2021
Partner Project No. 21-34725.1

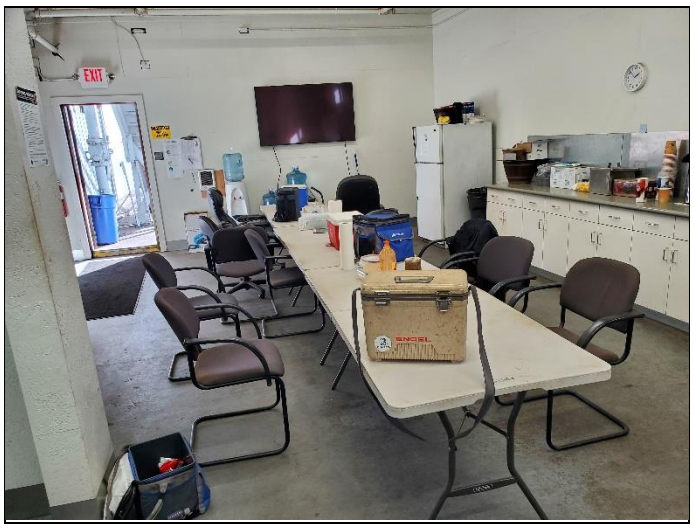
28. Entrance to employee break room.

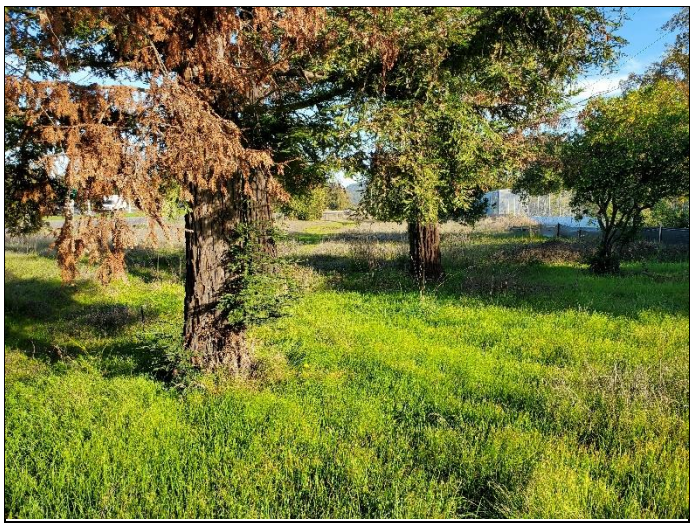
37. Small channel on southern portion of subject property and adjacent FedEx to the southwest
